DEPARTMENT OF TRANSPORTATION

Contract #: 04-0120F4Cty: SF/ALA Rte: 80 PM: 13.2/13.9File #: 69.28**WELDING INSPECTION REPORT****Resident Engineer:** Pursell, Gary**Address:** 333 Burma Road**City:** Oakland, CA 94607**Report No:** WIR-009148**Date Inspected:** 23-Sep-2009**Project Name:** SAS Superstructure**OSM Arrival Time:** 700**Prime Contractor:** American Bridge/Fluor Enterprises, a JV**OSM Departure Time:** 1900**Contractor:** Zhenhua Port Machinery Company, Ltd (ZPMC), Changxing Island **Location:** Shanghai, China**CWI Name:** Chen Xi**CWI Present:** Yes No**Inspected CWI report:** Yes No N/A**Rod Oven in Use:** Yes No N/A**Electrode to specification:** Yes No N/A**Weld Procedures Followed:** Yes No N/A**Qualified Welders:** Yes No N/A**Verified Joint Fit-up:** Yes No N/A**Approved Drawings:** Yes No N/A**Approved WPS:** Yes No N/A**Delayed / Cancelled:** Yes No N/A**Bridge No:** 34-0006**Component:** OBG Crossbeams**Summary of Items Observed:**

OBG CROSS BEAM CB1

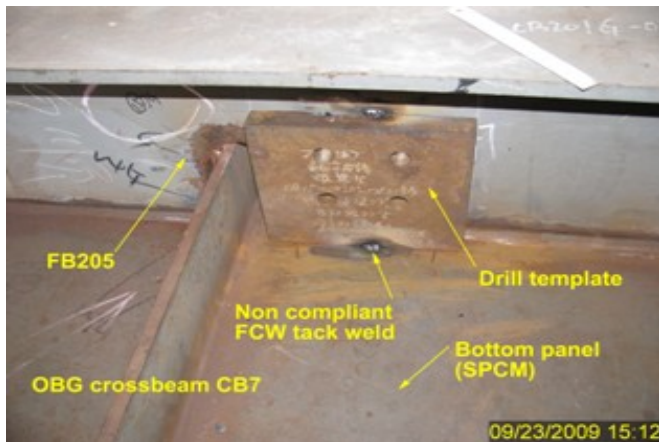
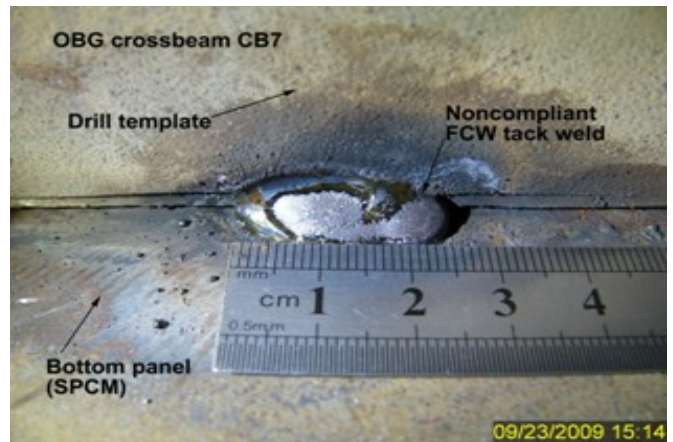
During random in process visual inspection of the above mentioned cross beam, this QA observed that the contractor appears to have tack welded temporary drill templates to the SPCM bottom panel of this crossbeam without the Engineers approval. Furthermore, the tack welds do not appear to meet the additional requirements of AWS D1.5 2002 section 12. The length of the tack welds measure approximately 25mm. This condition exists in the following locations: 2 locations on FB205 @ PP013, 2 locations on FB204 @ PP013, 2 locations on FB205 @ PP014, 2 locations on FB204 @ PP014, 2 locations on FB205 @ PP015, 2 locations on FB204 @ PP015, 2 locations on FB205 @ PP016 and 2 locations on FB204 @ PP016. AWS D1.5 2002 section 12.13.1.1 states "All tack welds used in assembly shall be located within the joint unless otherwise approved by the Engineer." AWS D1.5 2002 section 12, table 12.2 requires tack welds located outside the joint to be a minimum of 75mm in length. See attached photos for details. This QA notified ZPMC QA identified as Mr. Zhang Wei and ABF QA inspector identified as Mr. Kelvin Cheung of this issue and that an incident report would be generated.
